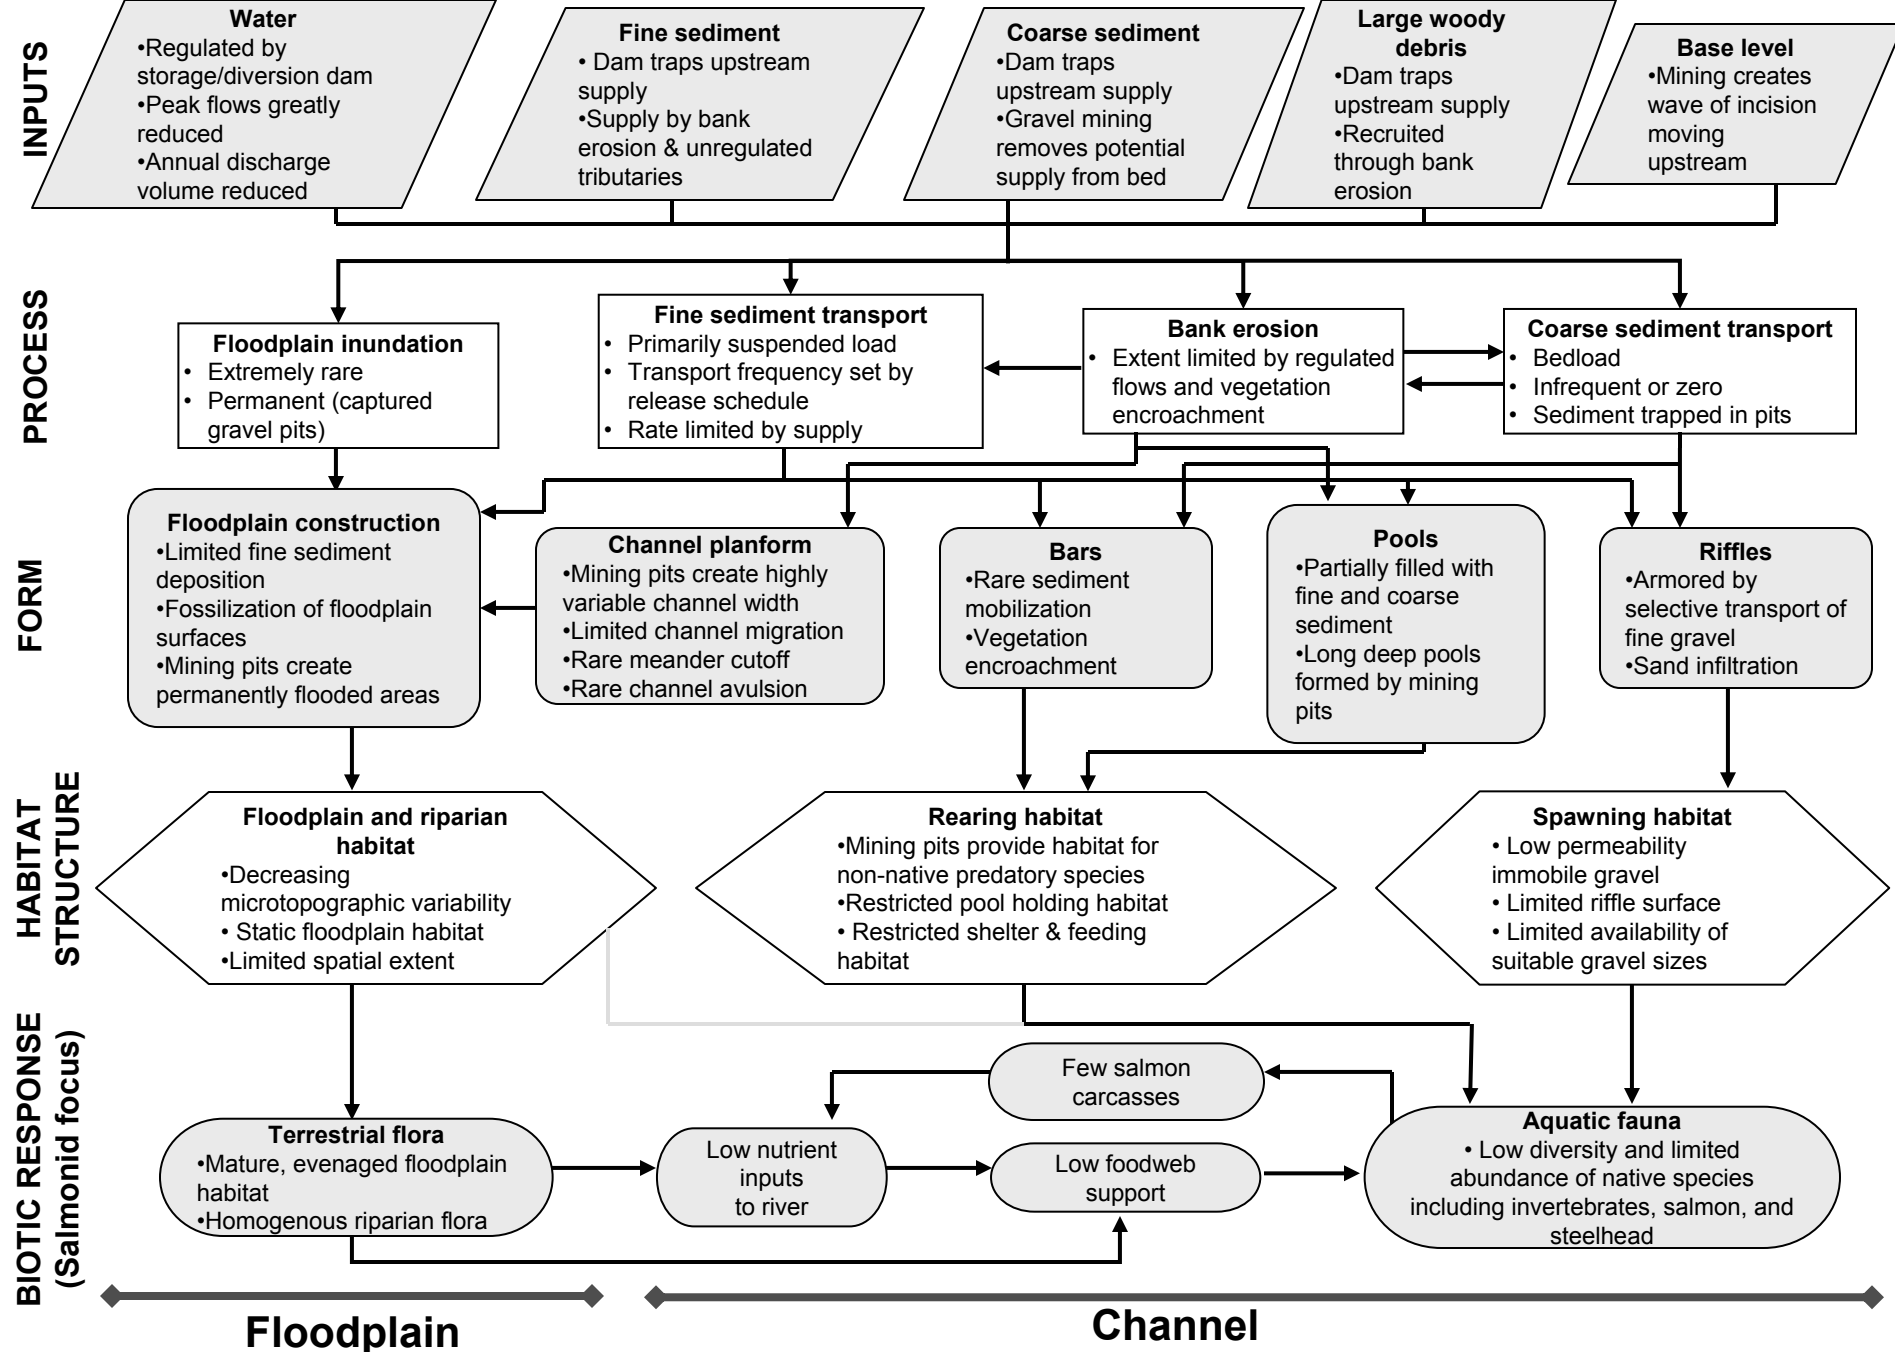
Figure 21: Gravel bed (unconfined) disturbed by dam and in-stream mining conceptual model.

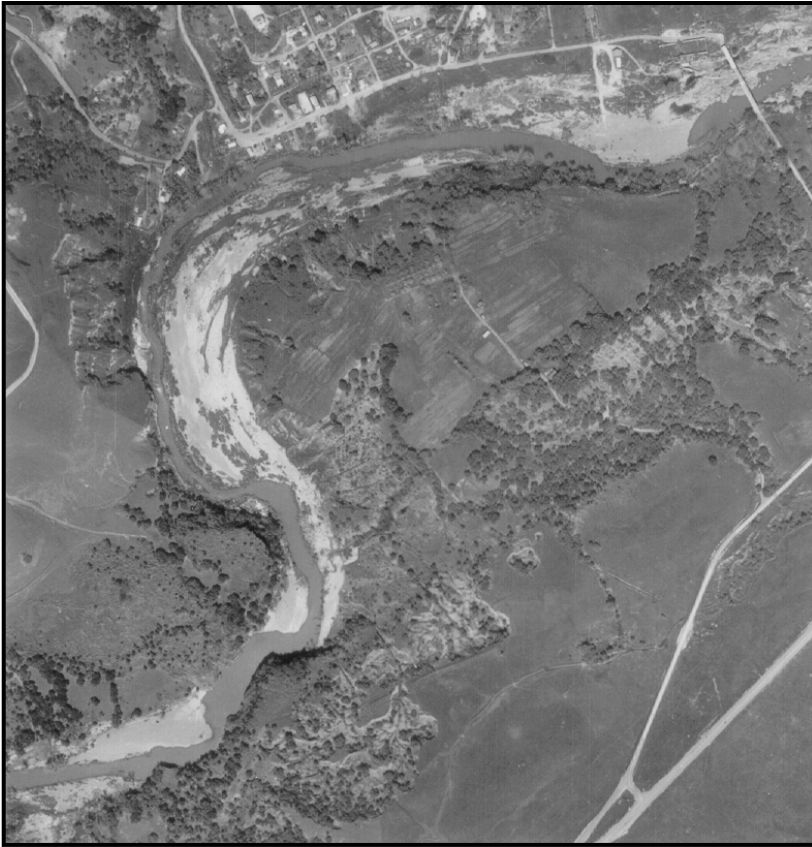
**Figure 23: Two aerial photographs of Knight's Ferry on the Stanislaus River. The 1957 photograph shows exposed bars and a wide channel with little riparian vegetation in the active channel. The photo from 1998 shows a narrow channel that is armored with riparian vegetation. These photos illustrate the channel simplification resulting from flow regulation from New Melones Dam, which was constructed in 1979. Source: Falzone (2001).**
